NUDGENE ROAD BRIDGE BEARINGS

PROJECT SUMMARY

Nudgee Bridge

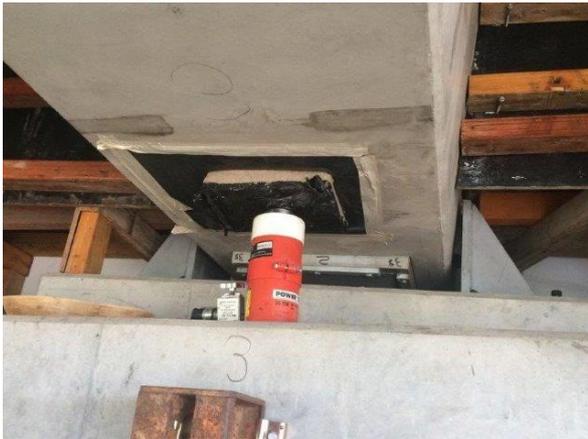
A 20mm support plate was placed on top of the jack to evenly distribute the load and these were grouted with fast curing Chemrite CR-FC grout.

Epoxy Solutions then fitted sensitive measuring equipment to each girder so any movement can easily be closely monitored. This was important to avoid damage to the structure as the adjacent bearings were epoxy grouted.

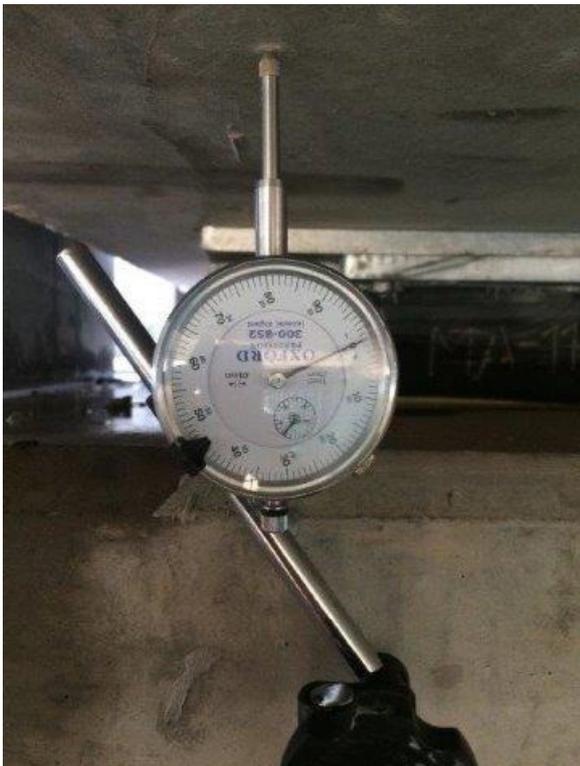
Each girder was then lifted to a point where each bearing could be removed. This was done using basic hand tools and much care was taken not to damage the elastomeric bearings.

Once the bearings were removed, the bolts securing the taper plate had to be cleaned. They

were grouted as part of the original grouting process. The epoxy was removed using a combination of heat and small hand tools.

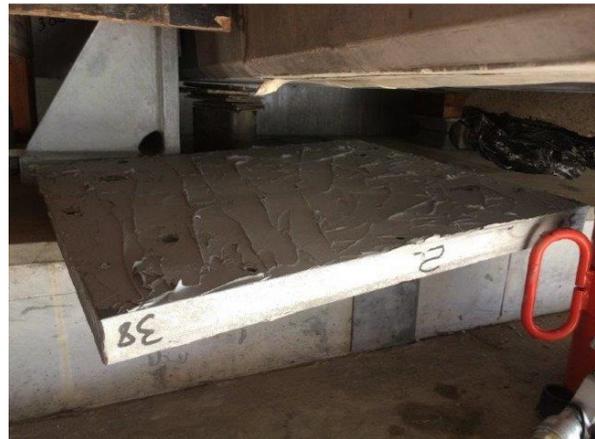
Once the taper plates were removed, they were cleaned and replaced with epoxy grout and new HD bolts.

Once the taper plates were bolted in place, the bearings were replaced and grouted. The load was then transferred back to the bearings and a thorough check on grout and positioning was done.
