R019 THE GAP RESERVOIR REHABILITATION PROJECT

PROJECT SUMMARY

The Gap Reservoir, The Gap

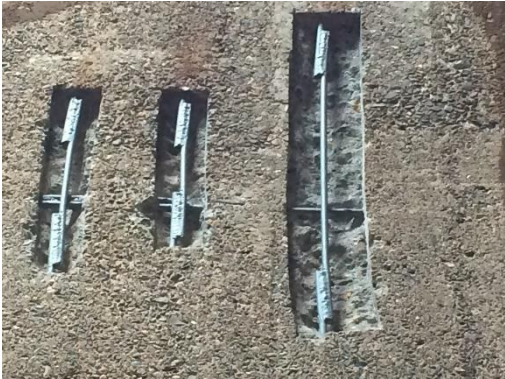
1. Reinforcement bars replacement 18m.

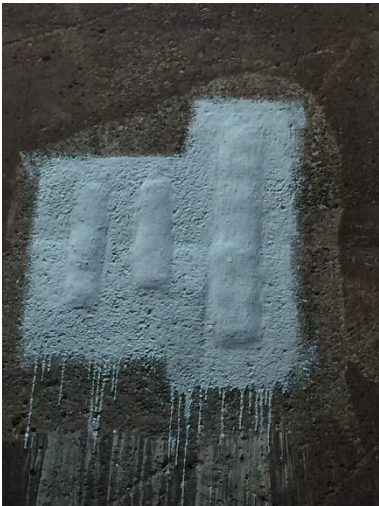
2. Concrete Repairs – 32 No. repairs on the internal reservoir wall with a .

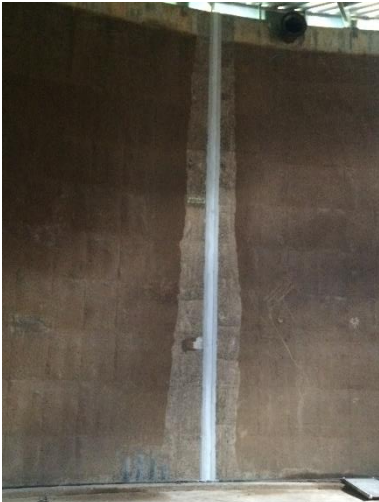
3. Sika Combiflex Joint Repairs 9m.

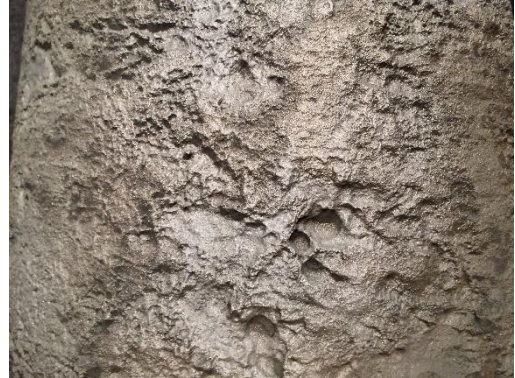
4. Abrasive Blasting

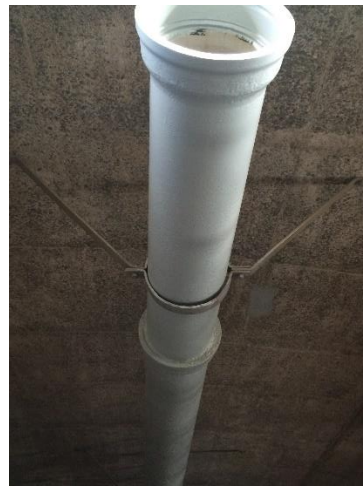
5. Coating the overflow pipe 15 m²
