## FERNY HILLS POOL

### PROJECT SUMMARY

Client: Morton Bay Regional Council

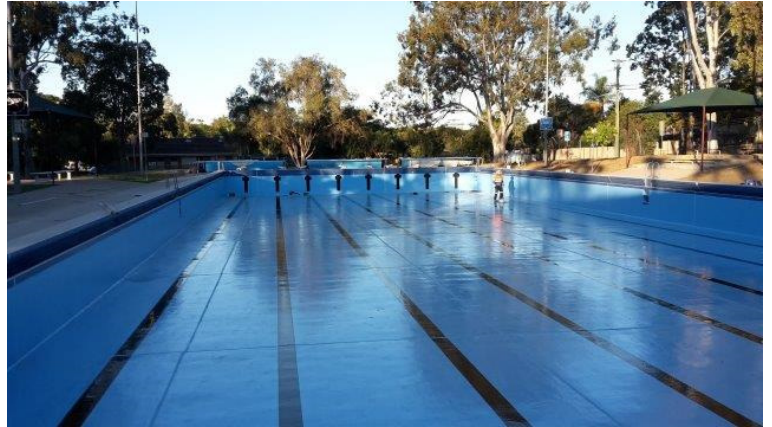
**Ferny Hills Pool –Scum Channel and coating completed**

The project consisted of the epoxy coating of the 50 meter pool along with the re-tiling of the scum channel and associated works. The previous coating was worn and had failed in many locations.

Moreton Bay Regional Council (MBRC) engaged Epoxy Solutions to apply three coats of Chemrite MC Pool epoxy and repair the scum channel.

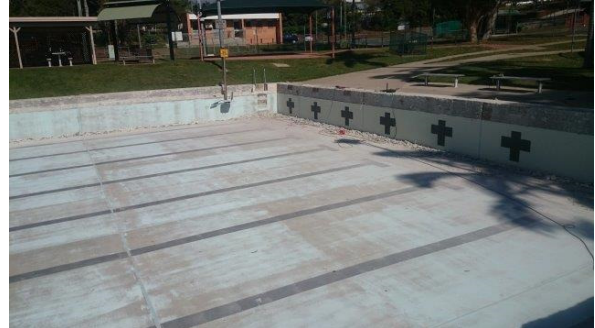
The photo below illustrates how the previous coating had worn and failed.
