REHABILITATION OF KARANA DOWNS RESERVOIR (R060) INTERNAL WALL

PROJECT SUMMARY

Client: Queensland Urban Utilities
(QUU)

Location: Karana Downs, Mount
Crosby

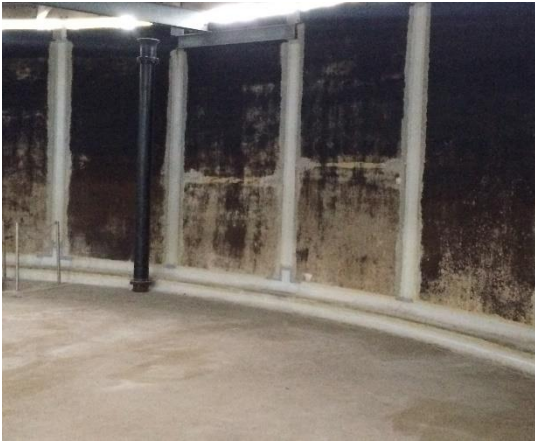
Remove existing coatings (Before)

- Grinding off the existing internal coating from the wall panels.
- Fill bug holes, remove high points and sharp edges in the internal wall panels
- Apply a polyurea coating (Tufflon – P90) as per the manufacturer’s recommendation

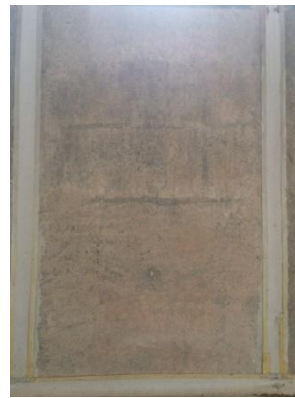
Remove existing coatings (After)

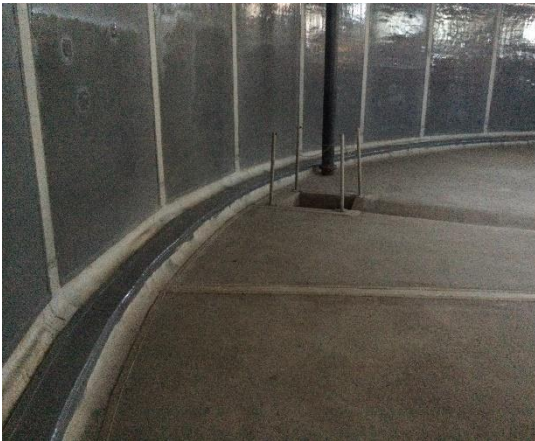
Reservoir walls and ringbeam coated with Tufflon P-90 (Polyurea coating).
